Dam ID: HI00005Mana Reservoir**Vulnerability Index:**Extreme High Moderate Low
1 2 3 4

Date: 3/23/2006STATE OF HAWAII - DLNR
VISUAL DAM SAFETY INSPECTION SHEETInspection Type: Dam Safety Inspection**Persons Present****Affiliation****Phone Number**

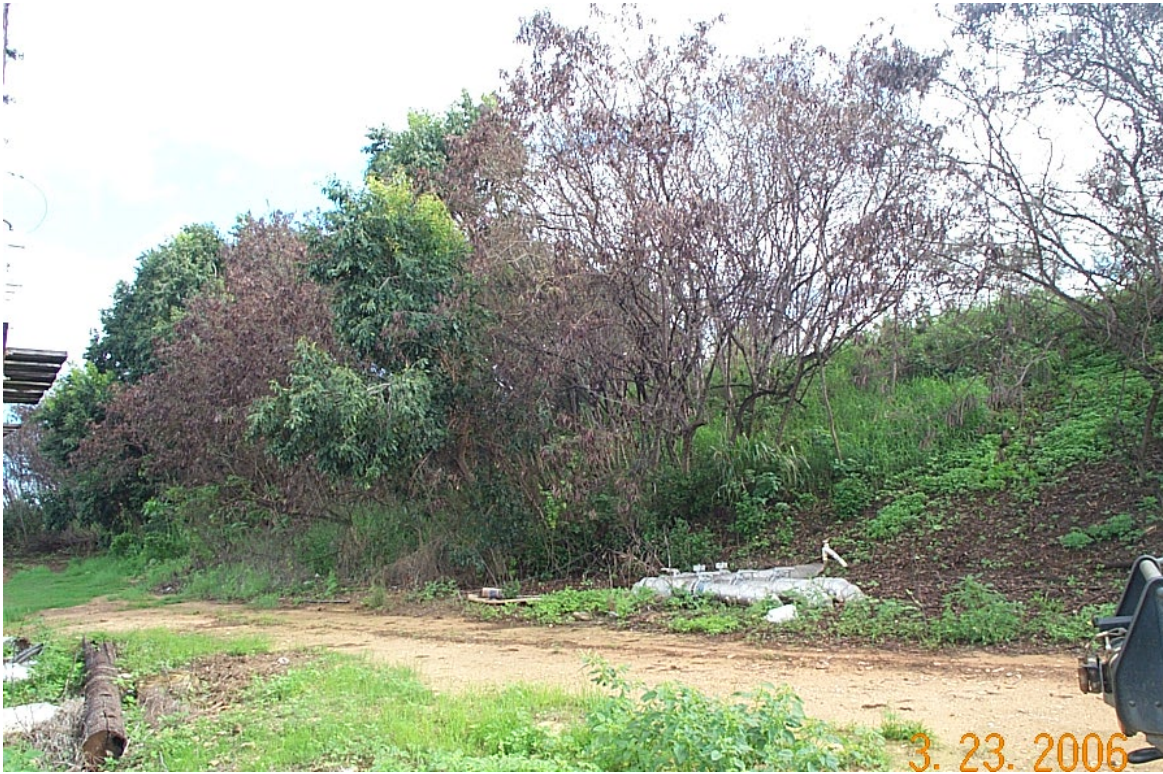
Vegetation: ☐ None ☐ Low Ground Cover ☒ Bushes or Tall Grass ☒ Trees # lots ☒ <6" ☒ >6" & <20" ☐ >20"

View of the downstream slope of the dam. Note brush and trees on the slope.

- ☒ g. Tree(s) were observed on the downstream slope. Trees have been identified as the probably cause of piping failures, and can possibly cause sever damage to the embankment if they are uprooted during a high winds. Corrective action is required to remove the tree hazards from the dam. Acceptable remedies include removal of the tree and its root structure down to a 2" diameter and reconstructing the damaged embankment section. All repair work shall be accomplished as per the requirements of licensed geotechnical or structural engineer. Routinely monitor the damaged area for signs of settlement and seepage.

1. The upstream and downstream slopes and crest of the embankment should be clear and visible for inspection. Underbrush should be cleared and grasses kept short. Trees have been allowed to grow so large in some cases that there is concern that seepage along the root systems may develop. There is additional concern that cutting and killing the trees will lead to rotten roots and greater potential for seepage. A more in depth evaluation of the vegetation conditions should be performed to determine how best to remediate the condition.

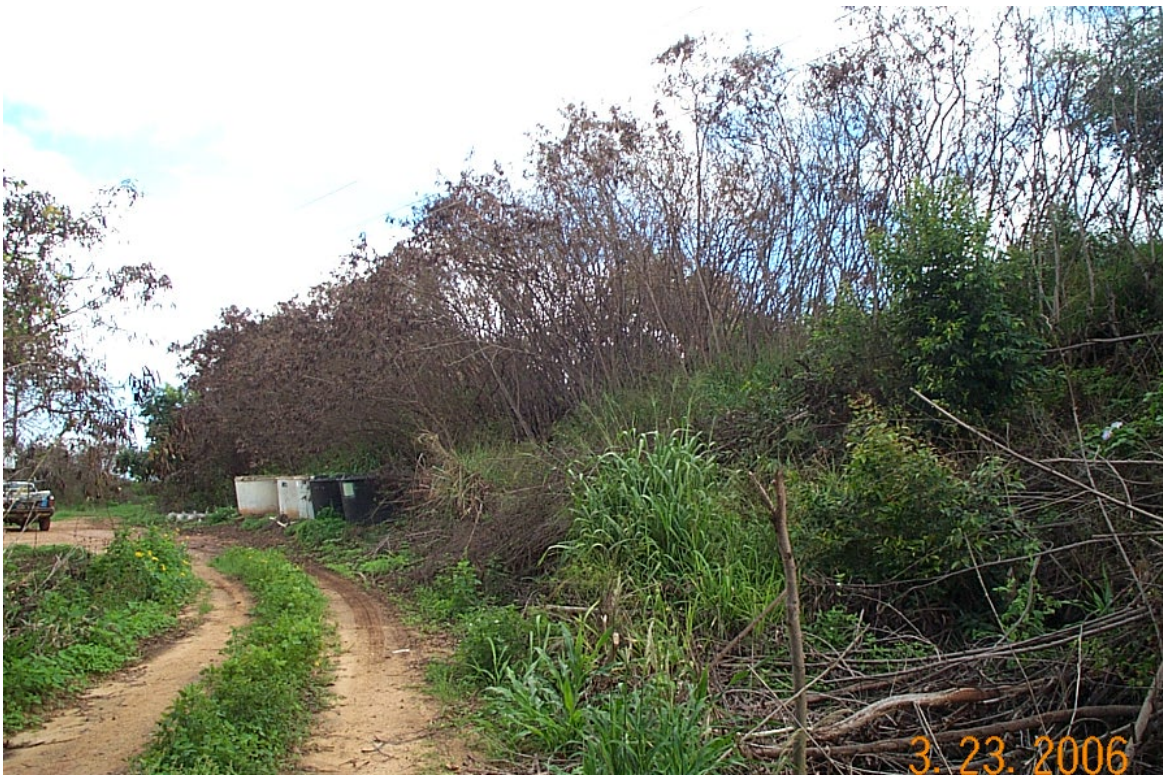
- ☒ j. The slope was very steep, around a 1 to 1 slope, further study is required to verify slope stability.
- ☒ k. Repair 3" PVC pipe. Repair should be done immediately. ***Urgent corrective action.***

View of the downstream slope of the dam. Note brush and trees on the slope.

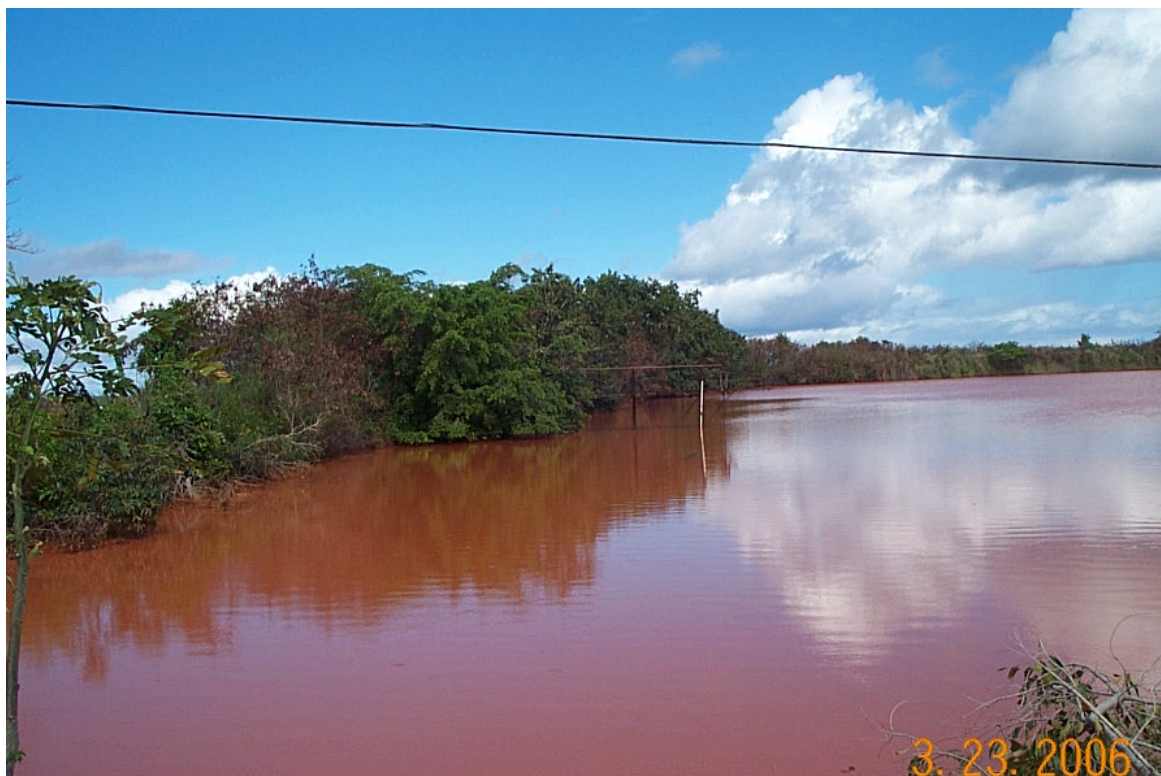
Description: benching of slope due to wave erosion

Description: multiple mature plum trees

View of upstream slope, reservoir, and outlet works intake structure.

- ☐ e. Slope protection needs maintenance or repair. Description: _____
- ☒ f. Rut and/or Gully erosion was observed on the slope, which requires maintenance and/or repair.
Description: benching of slope due to wave action; should repair erosion and consider placing stone protection.

- ☒ k. remove vegetation and trees from slope

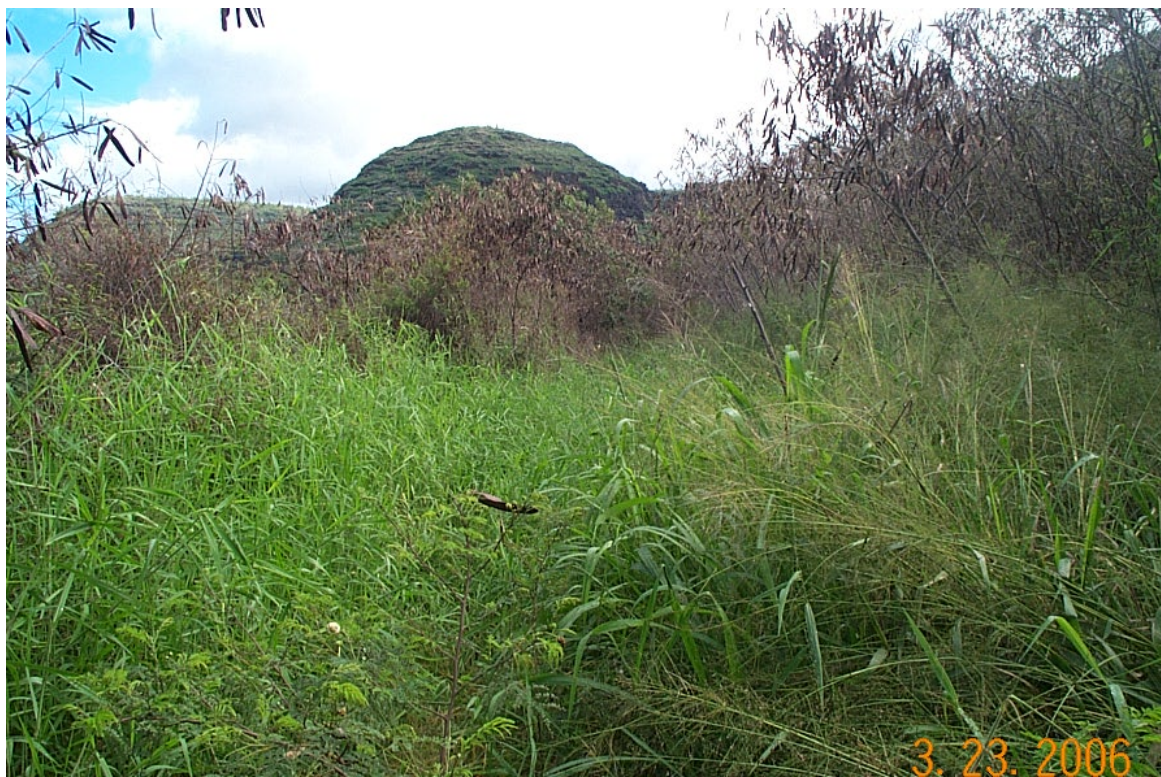
Description: unable to inspect entire crest due to heavy vegetation

Description: buffalo grass and haole koa

View of the heavily vegetated crest.

- ☐ i. A sinkhole was observed on the crest, which requires further investigation to determine the underlining cause. Repair and monitor the area.
- ☒ j. Portions of the crest were not visible due to high grass and bush vegetation. Clear high vegetation and maintain low to enable easy visual inspection.

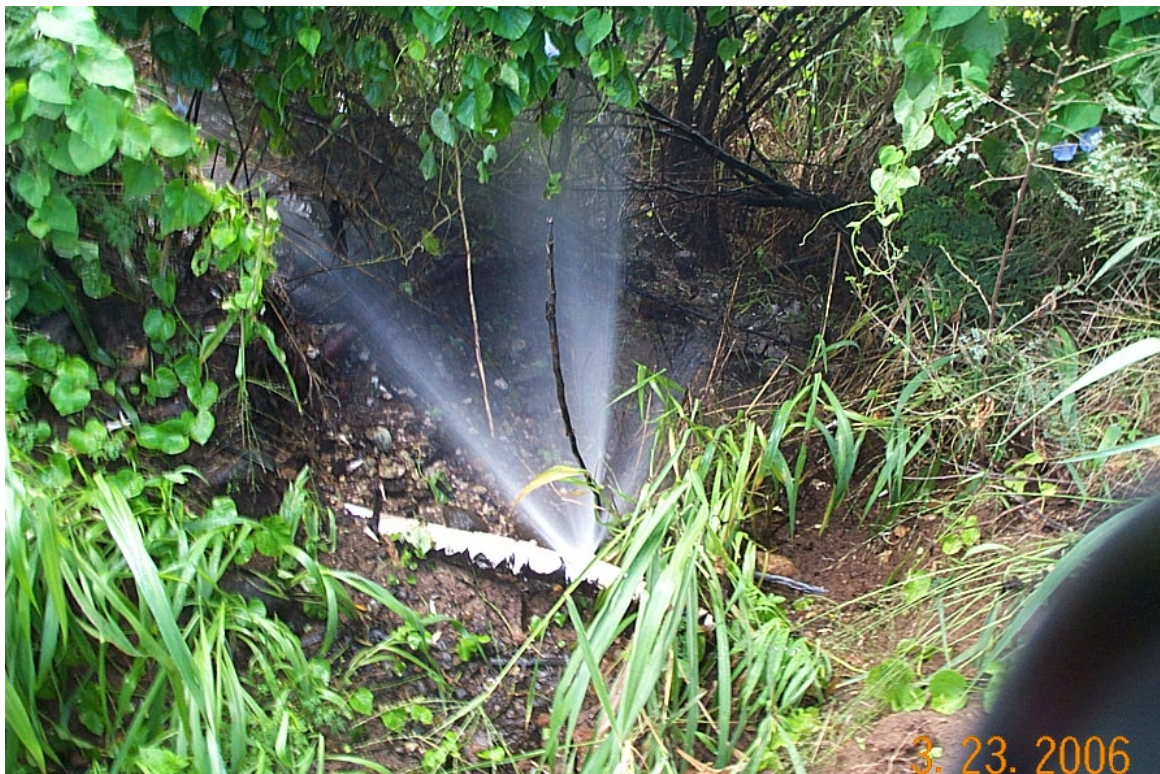
Description: single location with broken 3" PVC pipe spraying water on embankment; Repairs to pipe are urgent

Broken PVC pipe spraying water on the downstream slope of the dam. Pipe should be repaired immediately to prevent erosion of the embankment.

1. Repair the broken 3" diameter PVC pipe owned by cooperative
2. Clear the spillway ditch of sediments and vegetation

5. A PVC water line is located on the downstream slope of the dam. The pipe should be relocated off of the embankment. Significant erosion of the embankment could occur if the pipe breaks. Today's inspection encountered a section of broken pipe and the water was spaying on the embankment.
